ES_LPC4370/50/30/20/10

Errata sheet LPC4370, LPC4350, LPC4330, LPC4320, LPC4310

Rev. 7.2 — February 7, 2023

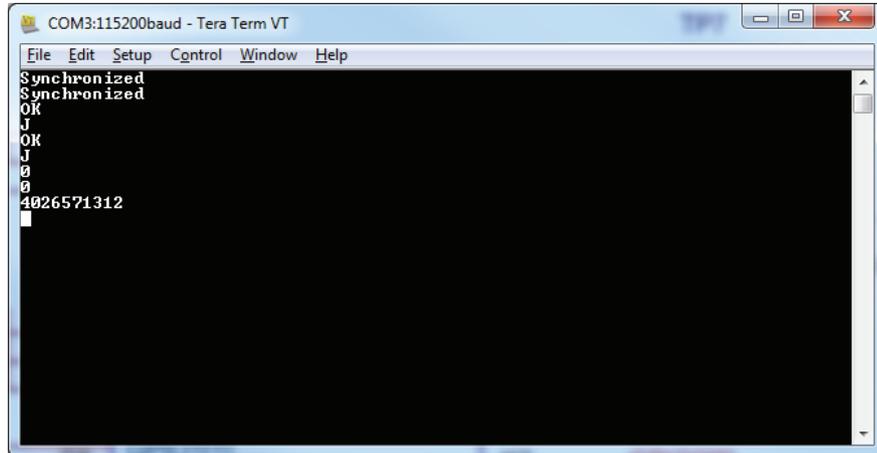
Incorrect example:

The 'J' command in ISP mode should return an error code, followed by an ASCII string representation of the part ID, followed by a 0. However what is actually returned is the error code, followed by a 0, followed by an ASCII string representation of the part ID. The problem is the last two items returned are swapped.

There is no work-around for this problem.

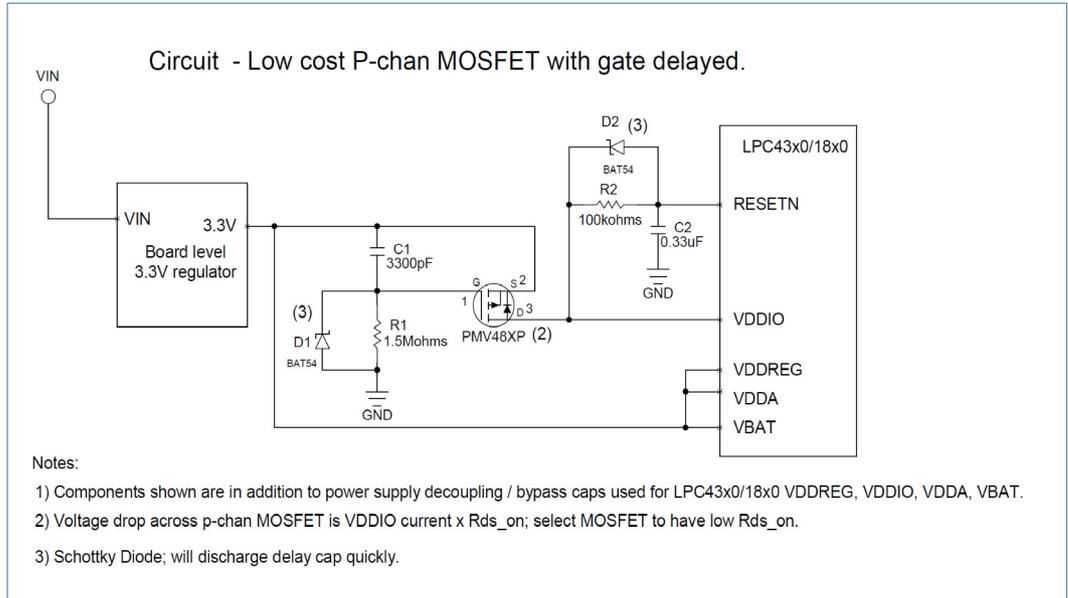
On all packages, repeated power cycling of the device may cause erroneous programming of the OTP banks. During ramp-up, the VDDREG supply voltage does not have enough time to settle and initialize the OTP controller before valid programming voltage is reached on the VPP pin. This may cause accidental programming of the OTP banks. Accidental programming of the OTP banks does not occur during Power-down of the supply voltage.

The following circuit diagram is an example that shows the P-channel MOSFET with the gate delayed and the R-C delay circuit connected to the RESETN pin.

- Do not tie VDDIO to VDDREG and VDDA pins. The power supplied to the VDDIO pin should be delayed by 2 ms after the power supply on the VDDREG and VDDA pins stabilizes at the operating voltage level. The signal to the RESETN pin must also be delayed by 2 ms after the power supply on the VDDIO pin stabilizes at the operating voltage level.

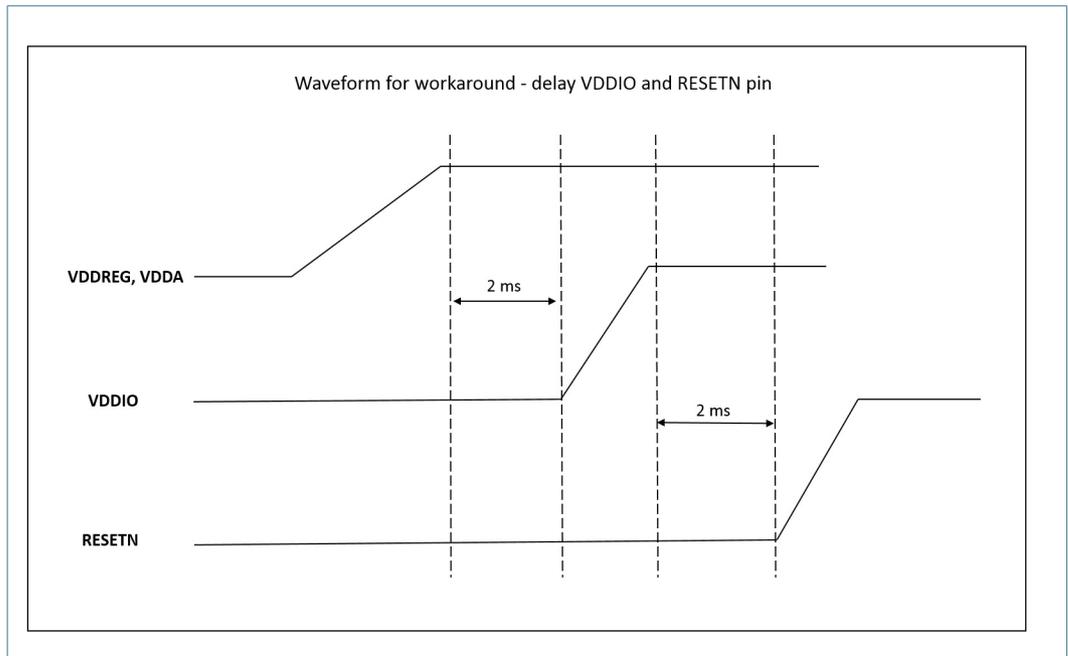
The following diagram shows the waveform for the work-around.

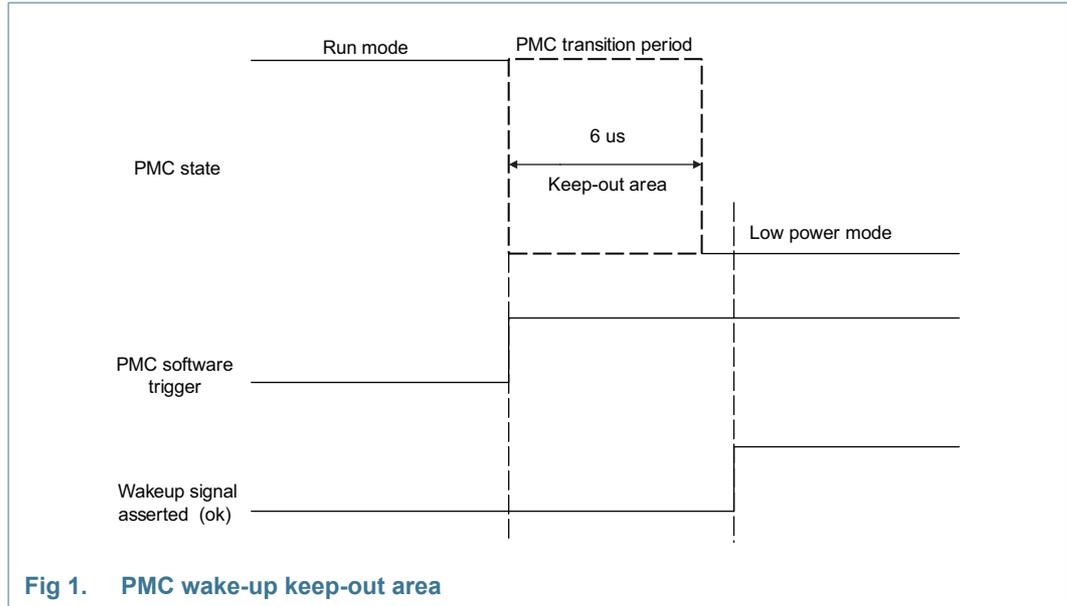
Fig 1. PMC wake-up keep-out area

When the chip is in a transition from active to deep Sleep, power down, or deep power down, wake-up events are not captured and they will block further wake-up events from propagating. The time window for this transition is 6 μ s and is not affected by the chip clock speed. After a wake-up event is received during the PMC transition, the chip can only recover by using an external hardware reset or by cycling power.

Make sure that a wake-up signal is not received during the deep sleep, power down, or deep power down transition period. An example circuit to work around this could include an external 6 μ S one shot which could be triggered via software using a GPIO line when entering deep sleep, power down, or deep power down mode. The one-shot's output could be used to gate the wake-up signal(s) to prevent receiving a wake-up signal during the PMC transition period. Depending on the system design, it may also be needed to latch the wake-up signal(s) so that they will still be present after the one-shot's 6 μ S time-out.

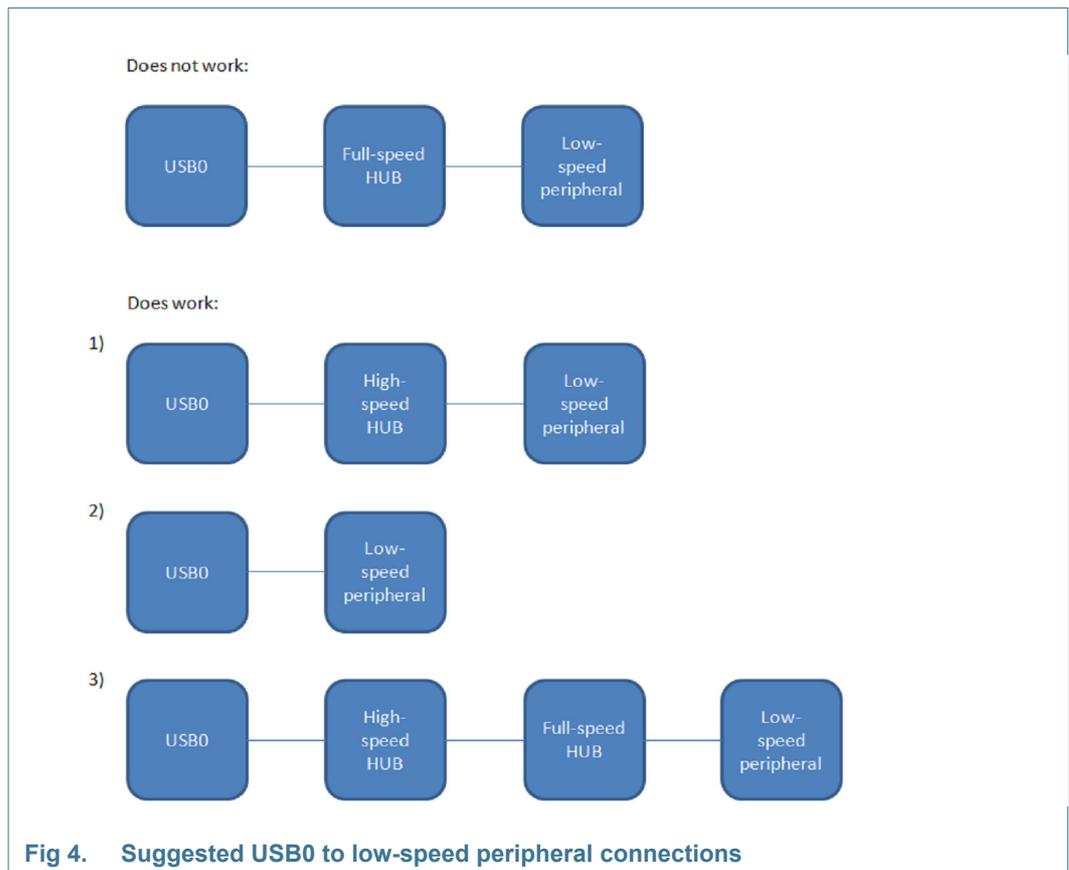
Fig 4. Suggested USB0 to low-speed peripheral connections

The USB controller called USB0 is unable to communicate with a low-speed USB peripheral in host mode when there is a full-speed hub directly connected to the USB0 port and a low-speed peripheral is connected in the tree somewhere below this full-speed hub. Only USB0 has this problem; the other USB controller, USB1 does not.

There is no work-around for this problem. It is suggested that the low-speed USB peripheral is either connected directly to USB0 or a high-speed hub is placed between that peripheral and USB0.

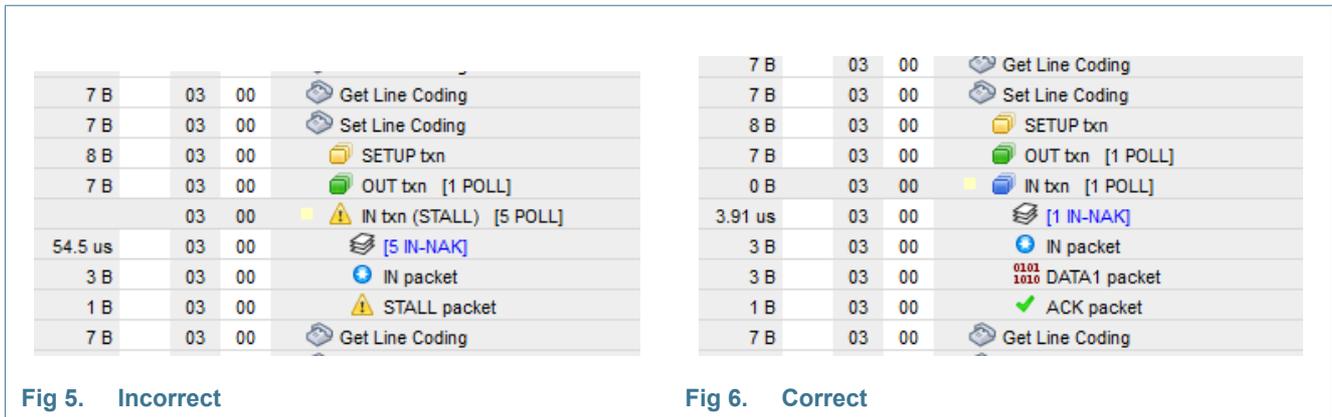
The CDC class USB ROM drivers return a STALL condition after the DATA stage of a Set Line Coding CONTROL transfer from the host. The correct behavior is to return an ACK.

The way to work around this bug is to override the default CDC class specific endpoint 0 handler and handle the processing of OUT packets in your application. Use the following source code in red to accomplish this.
